sub.net Power in the Savings

Save Costs with sub.net

sub.net is a compact, web enabled, multi-function substation monitor which provides valuable intelligence to help improve network management and enable substantial cost savings. Two key **sub.net** functions make significant cost savings possible for UK Utilities - fault location and asset management.

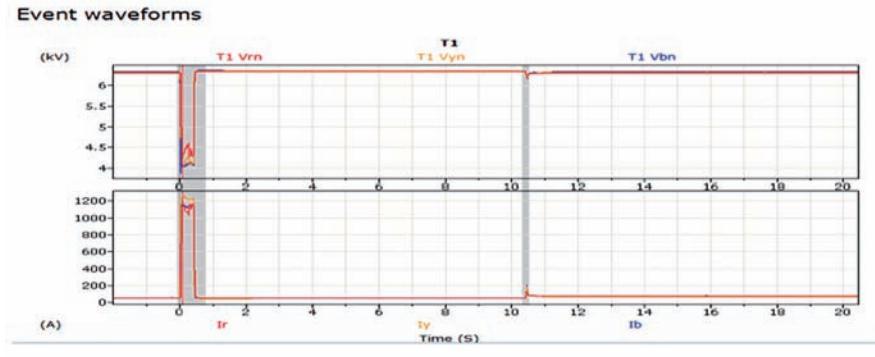
Fault location from Portballintrae

Impedance to fault circuit model search.

Line	Location	Easting Northing	UDB
FEEDER BREAKER 03	0.020 km past Line 876 TO Pole 87 SHORT SPUR		1284232
FEEDER BREAKER 03	0.050 km past Line 877 TO Pole 10 08/4451/003/P- SHORT SPUR		1285844
FEEDER BREAKER 03	0.234 km before Line 971 TO Pole 7 08/4350/001/P		1284222

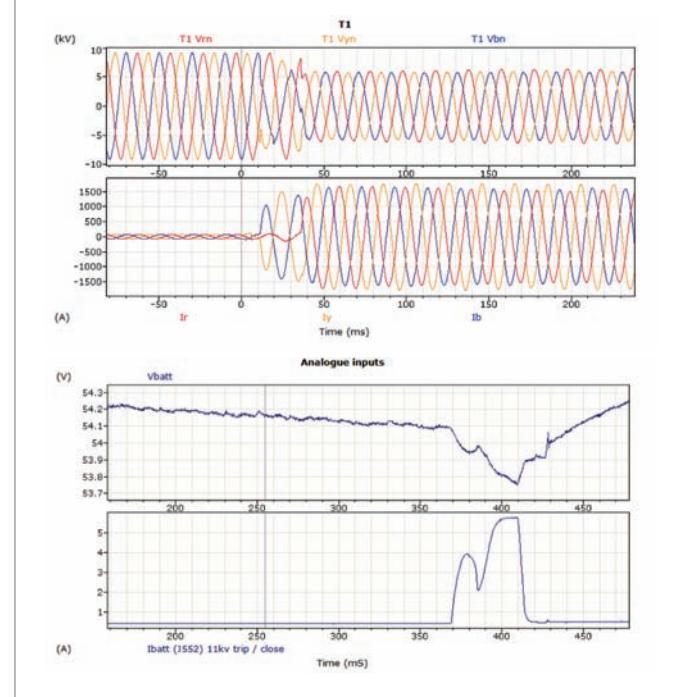
Waveforms and Breaker Measurements from a Fault Event Report

Switchgear operations during the event.

CB43-1844 (Trip) FEEDER BREAKER 03 at 415.5 mS

Operate time	68.4 ms
Coil current	5.260 A
Pulse width	46.4 ms
Aux contact	41.84 ms
Battery Vm	53.756 V
Battery impedance	0.036 R

CB43-1844 (Close) FEEDER BREAKER 03 at 10433.8 mS

Operate time	66.2 ms
Coil current	5.705 A
Pulse width	27.0 ms
Aux contact	36.23 ms
Battery Vm	54.009 V
Battery impedance	0.036 R

The tripping battery source impedance is measured to identify problems with cabling, connectors and battery cells (see breaker report above).
